***Formulation & Calibration of a
Numerical model of the tidal
hydraulics of McCormacks Bay***

A report submitted in partial fulfilment of
the requirements for the degree of
Masters of Engineering at the
University of Canterbury,
Christchurch, New Zealand.

James P.A. Flanagan
February, 1997

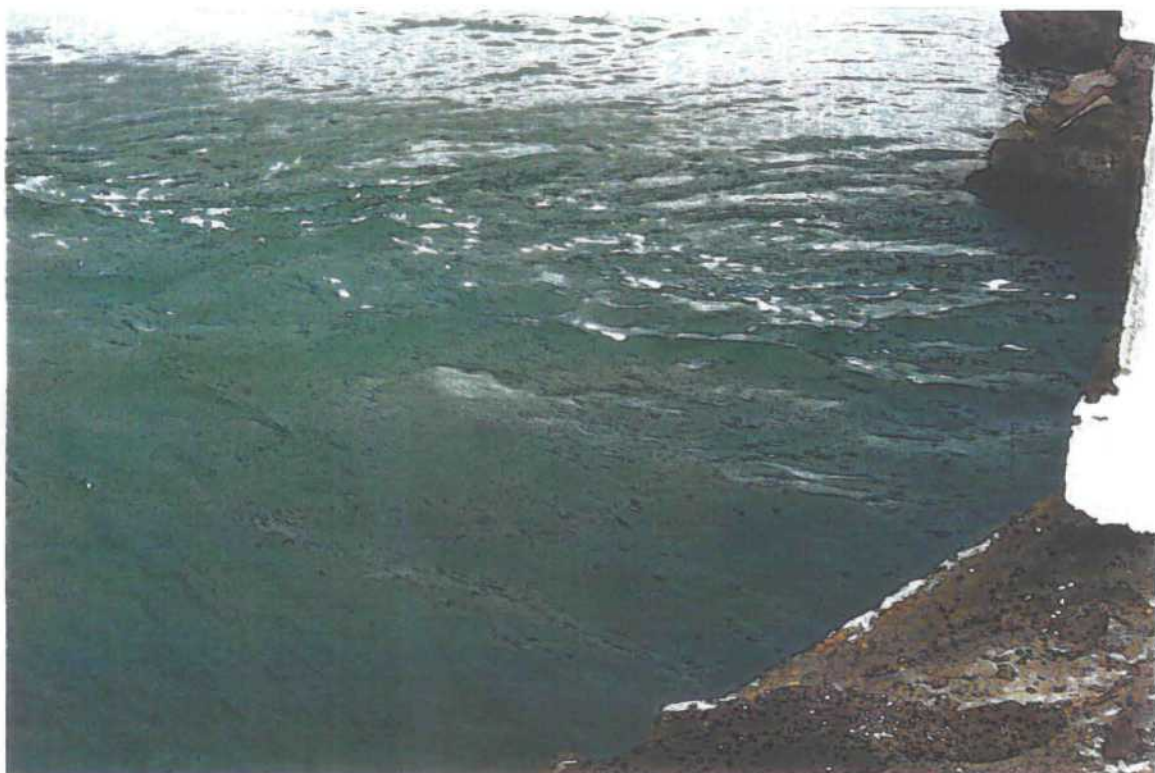
During the flood phase the flow is passing back into the estuary. In this regime differences between the levels in the bay and the estuary are less than in the ebb phase. This denies the ability of the tail water to drop below critical depth. It is in this flow regime that a significant jet opens up after the constriction of the culvert. **Figure 14 below, shows the jet coming into the bay.**
